Manhole Inspection Summary

Manhole # S37WW_027MH

Insp Date: **1/4/07 8:37 AM**

Location Address: **414 31ST ST**

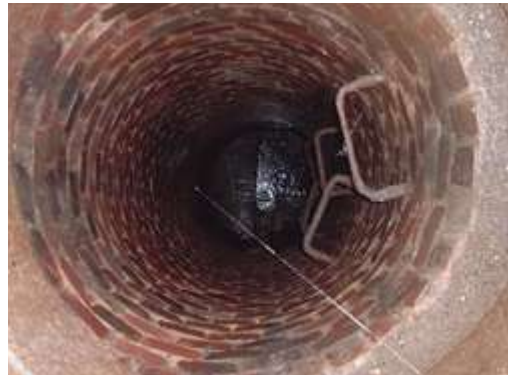
Top View

☒ **Debris** (not Condition related)

Count: **10** Missing: **0** ☒ **Corroded**

Corroded steps. Bench debris.

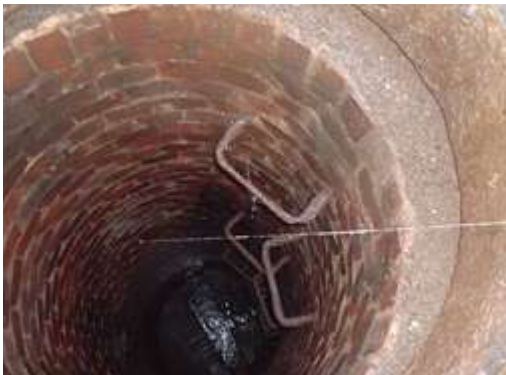
Defect

Offset: **2** (in.)

☒ **Leaks**

Infiltration: ☐ None ☒ **Joint** ☐ Cracks ☐ Mortar ☐ Roots ☒ **Wall**

Infiltration: ☐ None ☐ Joint ☐ Cracks ☐ Mortar ☐ Roots ☒ **Wall**

Frame leaks. Frame offset. Adjustment and Barrel infiltration.

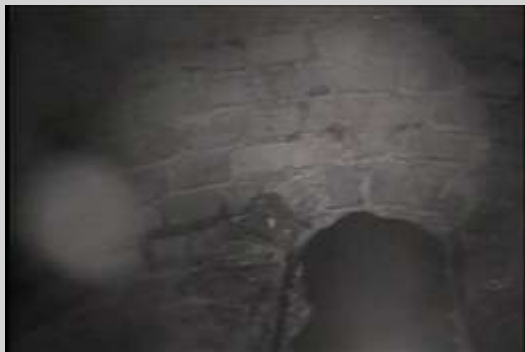
12 in. Circular Gravity Sewer Pipe Out @ 12 O'Clock

Infiltration: **None** Pipe Seal Cond: **Broken**

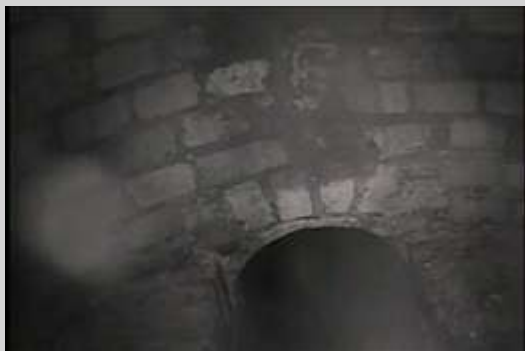
12 in. Circular Gravity Sewer Pipe In @ 3 O'Clock

Infiltration: **Evidence** Pipe Seal Cond: **Unknown**

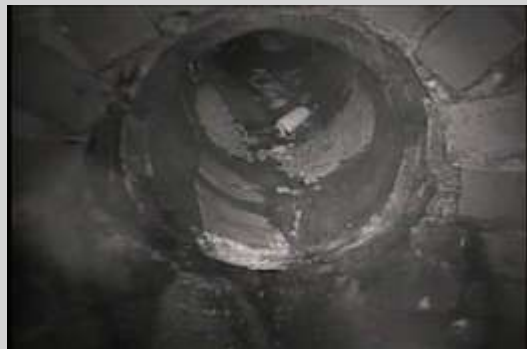
Pipe In @ 6 O'Clock

Infiltration: **Evidence**

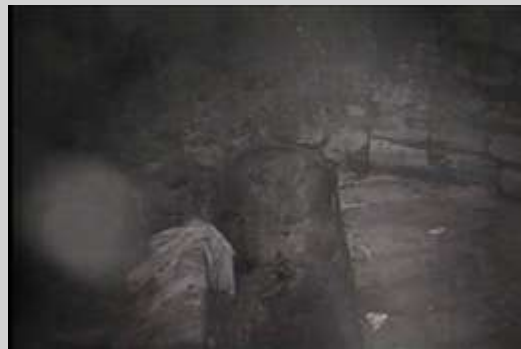
Drop In @ 6 O'Clock

Drop: **Outside** Rod and Bar

Drop Condition: **Open**
